Town of Arlington

DRAFT REPORT

ADA Self-Evaluation (as basis for Transition Plan)

Prepared by
Institute for Human Centered Design
September 15, 2014

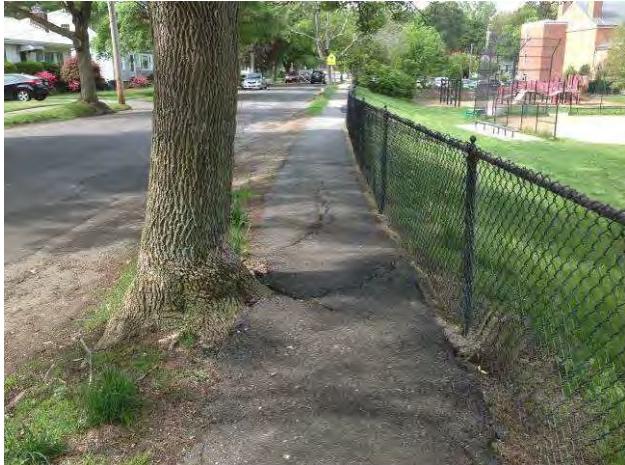
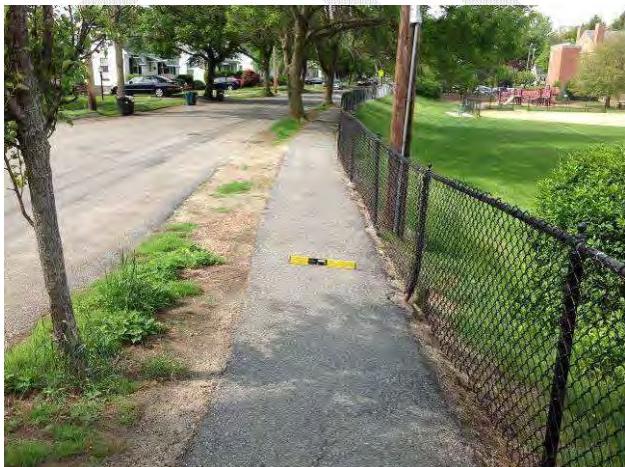
Although the sidewalks along Columbia Road are mostly accessible, the sidewalk along Stowecroft Road is in poor condition. Not only are a few sections near trees extremely deteriorated but also the sidewalk has excessive cross slopes and unprotected edge at certain sections of the fence. (Photos 2 and 3)

- 1 Crosswalks and Curb Ramps:** Install curb ramps at the intersection of Columbia and Stowecroft Roads.
- 2 Sidewalks:** Repair the sidewalk along Stowecroft Road.

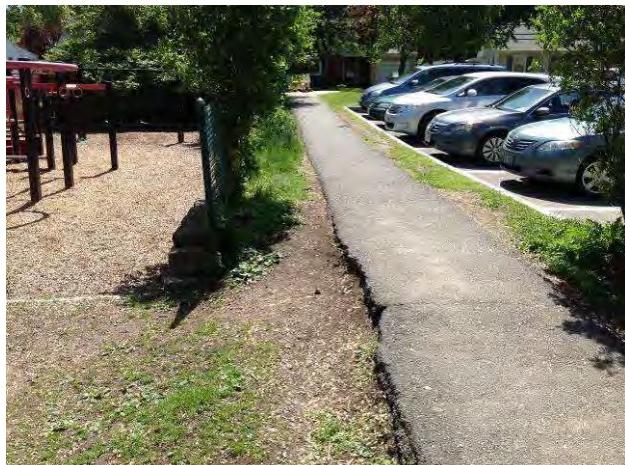
Photo 5

There are two points of entry in this facility along Stowecroft Road: one at the parking lot and one near the baseball/little league and soccer fields. The point of entry at the parking lot has an unprotected edge near the playground that is hazardous to those using wheeled mobility devices or who may be unobservant. (Photo 5)

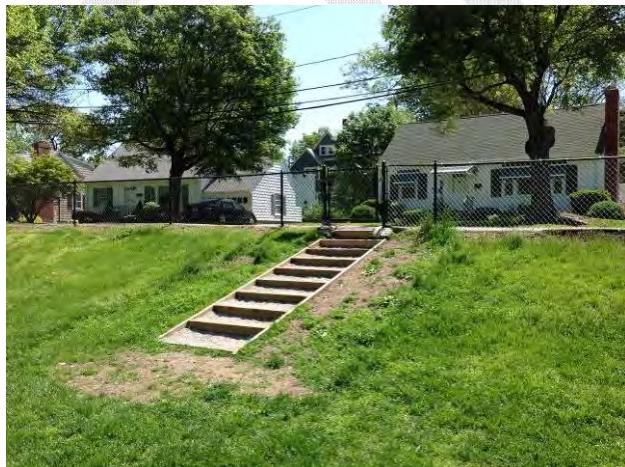
Photo 6

Additionally, the stairway leading to the baseball/little league and soccer fields does not have compliant surfaces and railings. Further, this inaccessible point of entry does not offer an ADA-compliant sign directing the public to the accessible point of entry 150 feet away. (Photo 6)

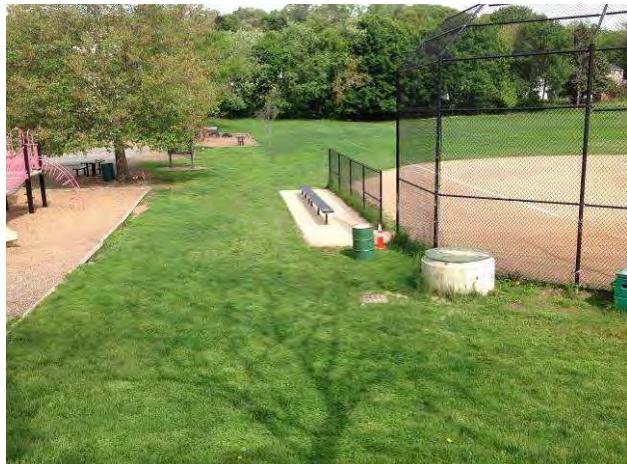
Photo 7

Although an asphalt walkway is provided between the point of entry at the parking lot and one playground and the basketball court, no accessible route is provided between either point of entry and the softball/little league and soccer fields. (Photo 7)

No accessible route is provided to either team seating areas adjacent to the softball/little league field. Although there is enough space for accessible integrated wheelchair seating locations within each dugout, they are not properly identified. (Photo 7)

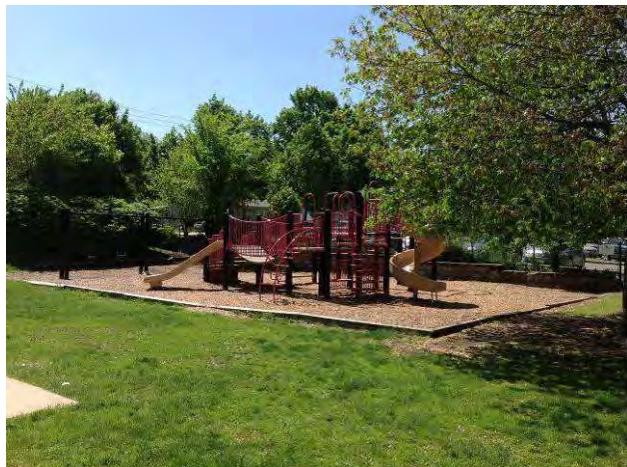
Photo 8

Although the wood fiber surface is currently well maintained and has compliant slopes, no accessible route is provided to the playground on the East side of the basketball court. (Photo 8)

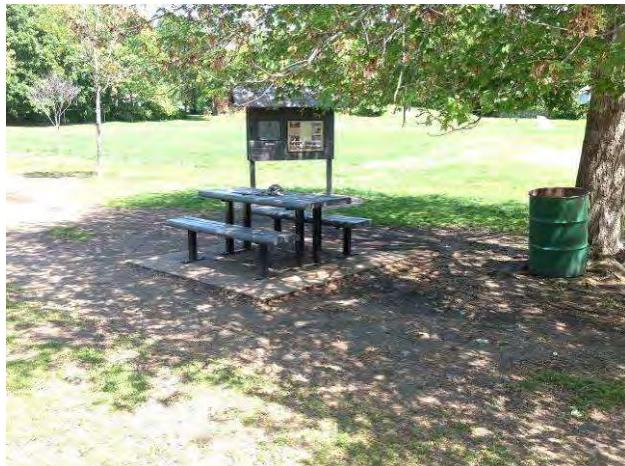
Photo 10

Three picnic tables are provided near both playgrounds: one near the parking lot, the other near the playground on the West side of the basketball court. None are accessible or are provided on accessible route. (Photo 10)

- 8 Tables:** Replace the picnic table with an ADA-compliant amenity and extend the asphalt walkway to it.
- 9 Benches:** Relocate one of the benches to an accessible area or install an accessible walkway to it.

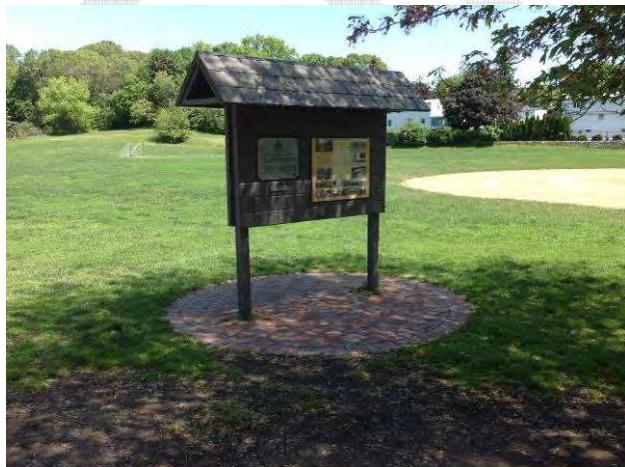
Photo 12

A bulletin board is provided between at the edge of the grassy field; however, it is not located within an accessible route. (Photo 12)

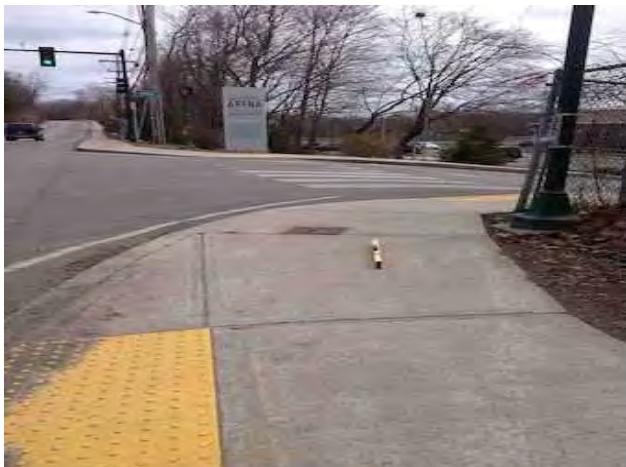
Photo 1

Sports Complex crosswalk areas at Summer St. & Ryder intersection are not connected to an accessible path of travel leading to Buck Field entrance. (Photo 1)

Recommendation: See Sports Center Complex, Site Arrival Survey, Part C.

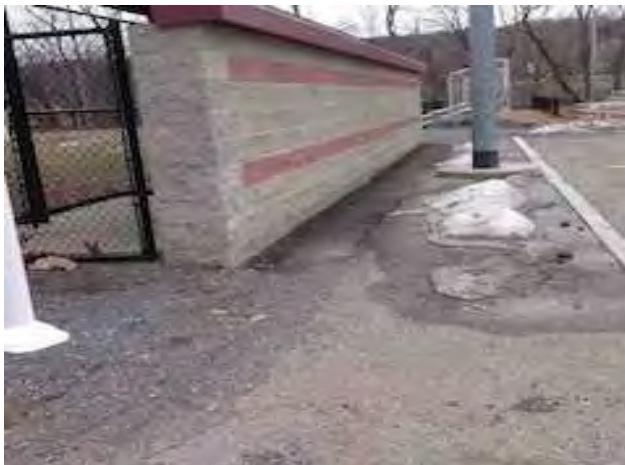
Photo 2

Sidewalks adjoining Buck Field facility areas contain many obstructions, uneven and warped surface areas, are made of dissimilar materials causing vertical level changes, and do not provide accessible path of travel to any facility areas, elements and amenities along the exterior approach and entrance routes. (Photo 2)

There needs to be at least 1 accessible path of travel providing a connection between the Sports Complex facilities and all exterior areas, elements and amenities, including accessible entrances, accessible parking spaces, seating amenities, informational sign installations, and trash receptacle.

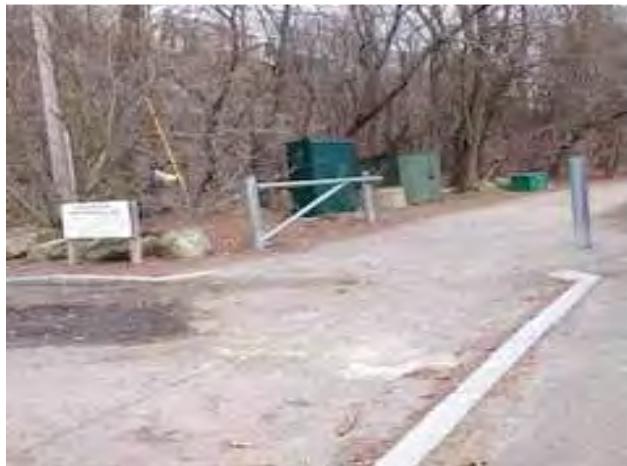
Photo 4

There is not at least one accessible route to connect Buck Fields and Hill's Hill facility to the accessible parking spaces, public streets and sidewalks and public transit nearby. These facilities are also not connected via at least one accessible route to the other programs, facilities and public amenities within the Sports Complex. (Photo 4)

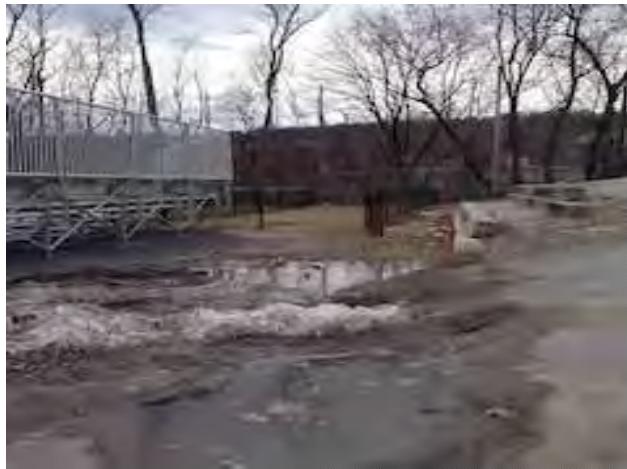
Photo 5

There is not at least one accessible route linking all program areas offered at Buck Field together and to the at-grade entrance. (Photos 5 and 6)

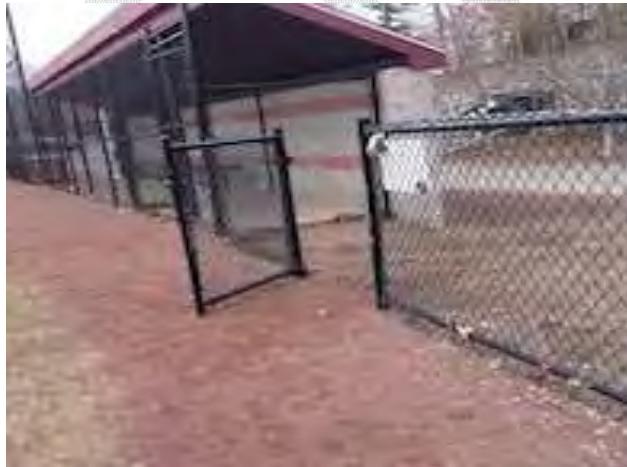
Photo 6

Alterations were completed without provision of an accessible route to and within the clubhouse and team seating areas. (See Photo 6)

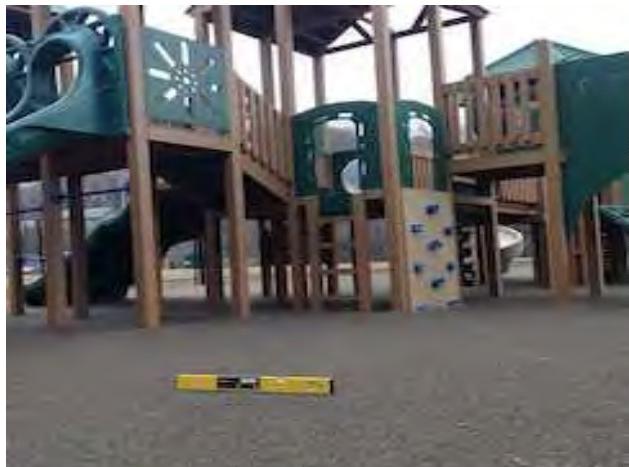
Photo 11

At the large play component area, the unitary ground surface does not have consistent levels and there are excessive cross slopes between and at the entry and exit points of accessible play components.

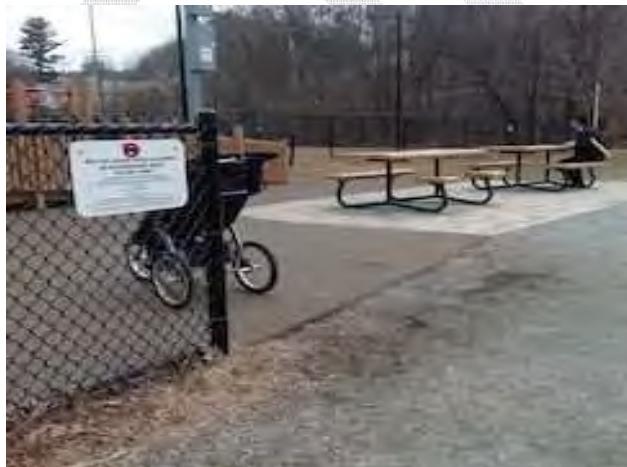
Photo 15

A picnic area with two tables is provided at the front of the playground area and there is a picnic table at the back of the playground area as well, near the fence. There is also a picnic table located outside the fence near the team clubhouse, which clutters an already narrow and excessive sloped route from adjacent parking spaces to facility entrance. There are no accessible tables provided; however, there is adequate level ground space for accessible seating alongside the tables in the front. (Photo 15)

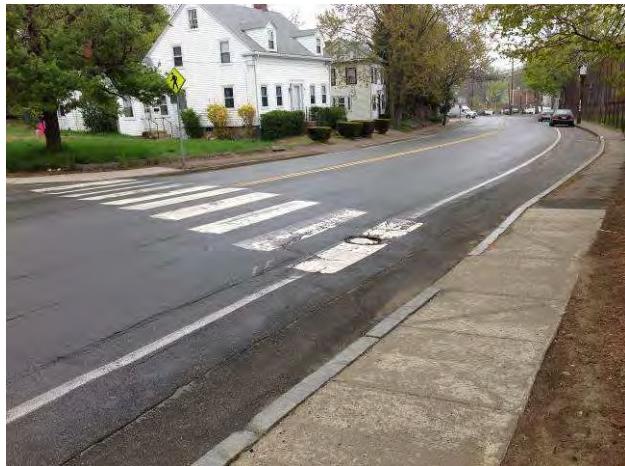
Photo 1

At the intersection of Summer Street and Victoria Road, a highly visible pedestrian crosswalk leads to one of the point of entry to this facility. The curb ramp is inadequately constructed and is missing the top level landing. (Photo1)

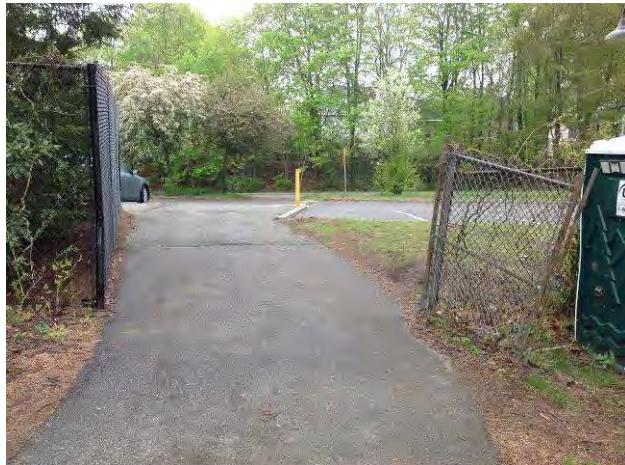
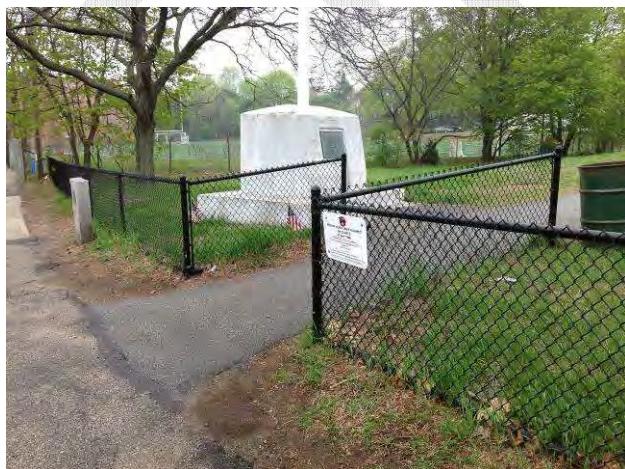
Photo 2

There are two points of entry in this facility: one on Summer Street and one on Russel Place / bike path. Both points of entry have walkways with excessive slopes. (Photos 2 and 3)

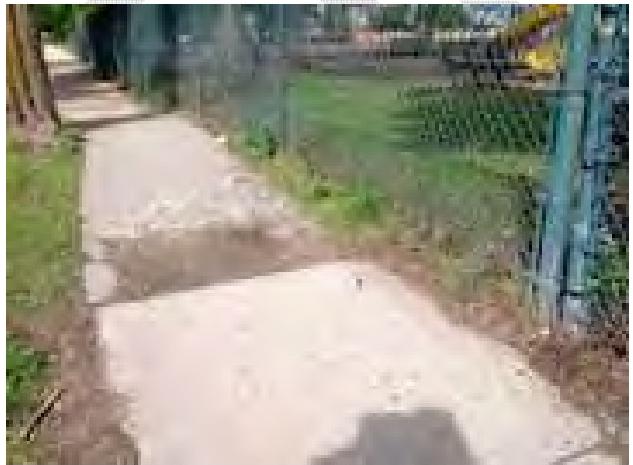
Photo 3

Oxford St. sidewalks are in disrepair with large panel gaps, level changes, varying widths, excessive slopes and not smooth. (Photo 3)

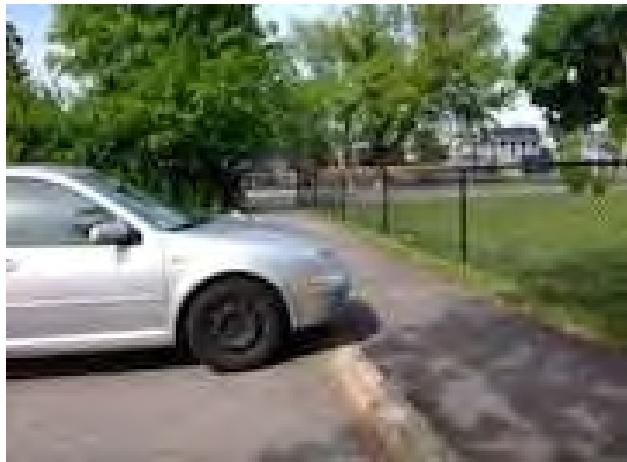
Photo 4

The reserved adjacent parking lot includes a back paved path connected to facility's hopscotch/four-square court and interior walkways. This path requires maintenance for level changes and slope issues. (Photo 4)

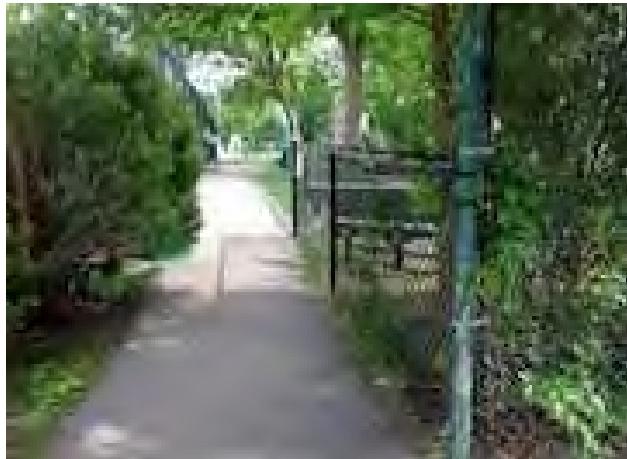
Photo 5

The main facility entrance, with signage, is along Oxford. There are exterior approach and entry sidewalk issues here, including change of level and excessive cross slopes. The interior walkway and entrance is well maintained.
(Photo 5)

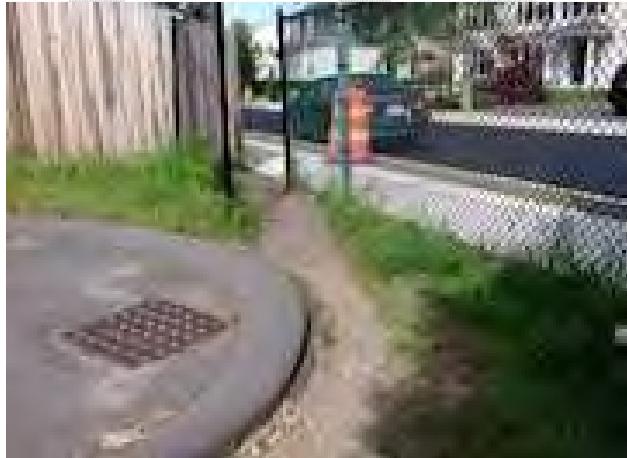
Photo 6

The entry from Oxford is inaccessible and not safe. The entry point is between a narrow fence opening and includes a dirt path that is narrow, not smooth and level, and is overlapped by the high level changes inscribing the Basketball/Singles Tennis court area.
(Photo 6)

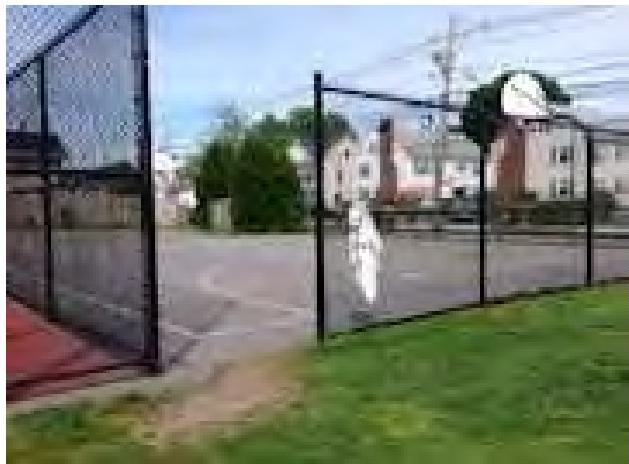
Photo 8

The paved interior walkway does not provide an accessible connection into the bordered playground. (Photo 8)

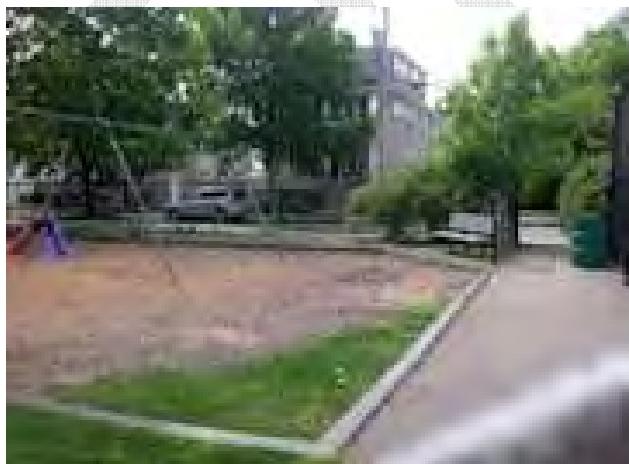
Photo 9

The play area with loose-fill ground surface materials does not include an accessible point of entry due to the border fully surrounding the perimeter of this play area. (Photo 9)

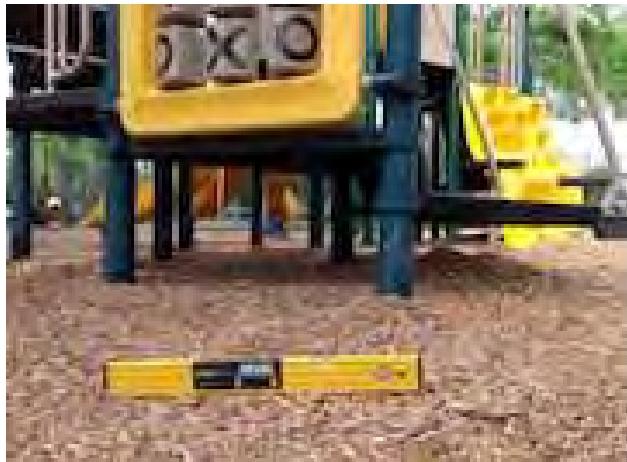
Photo 10

The playground loose fill materials have excessive cross slopes at some entry/exit points, such as at the spring rocker, at the bottom (exit point) of some slides, and at some transfer steps on the large composite structure. These ground surface issues are a current barrier to accessible circulation to and between ground play elements. (Photo 10)

a. If only loose fill ground surface materials are used, a high-frequency maintenance policy needs to be in place to ensure accessibility of ground surface materials in play area use zones through all seasons.

b. If ground surface materials will be replaced: consider adding impact-attenuating tiles within the playground areas to provide accessible routes and clear ground spaces to all entry/exit points of ground play elements, including swingsets, spring rockers and play structure.

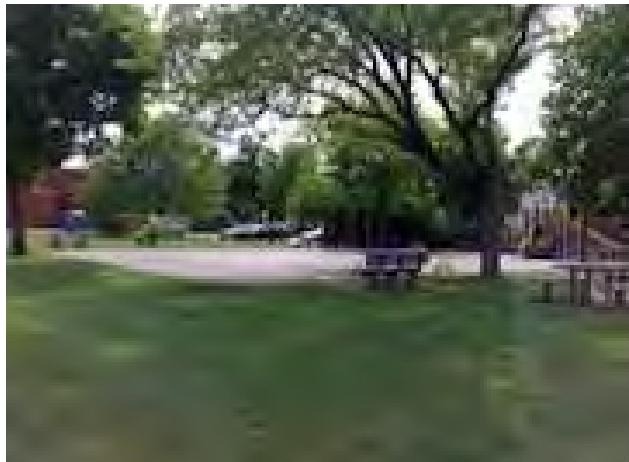
Photo 13

The Open field is one of the Town's scheduled soccer practice fields, and provides a lovely grassy space at other times. Picnic tables are in the field and benches are along the field perimeter. The field is adjacent to the ground games court which is connected to the accessible interior walkways. (Photo 13)

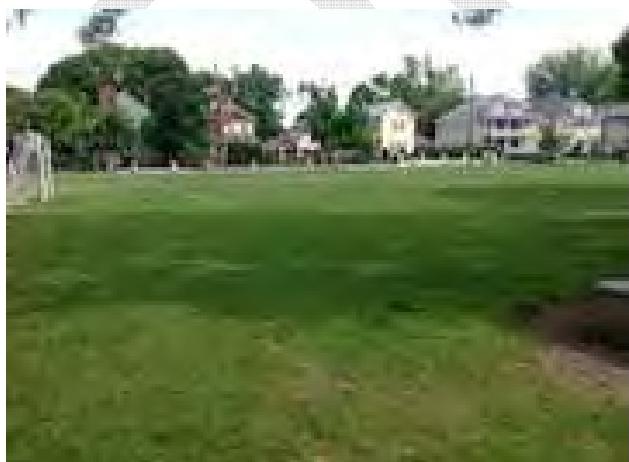
Photo 14

The perimeter of the field play areas and elements and amenities supporting field activities (such as benches, picnic tables and the porta potty) are not connected along at least one accessible route with the playground, Basketball court, and accessible entrance to facility. (Photo 14)

Extend the asphalt walkway to portable toilet amenity (about 75 feet).

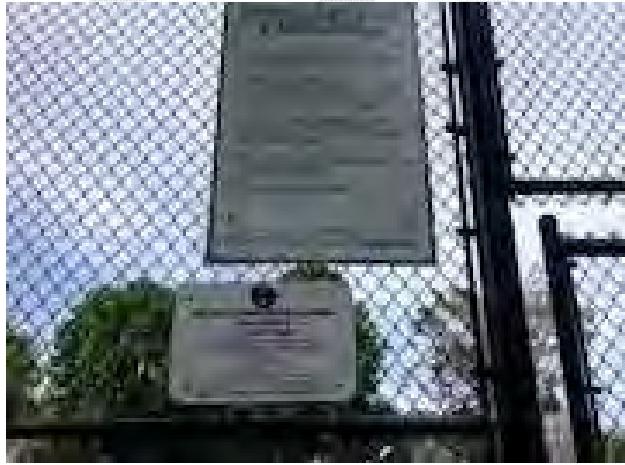
Photo 17

Informational Signage regarding Tennis Court rules is posted on the fence. This information is mounted too high for comfortable viewing. There is no information regarding how to obtain this information in alternate accessible formats. (Photo 17)

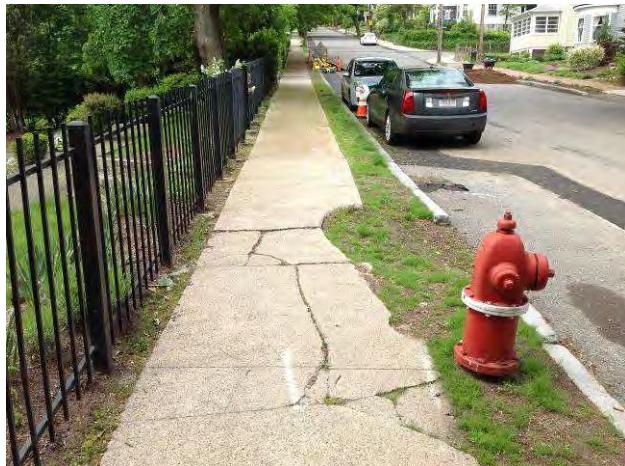
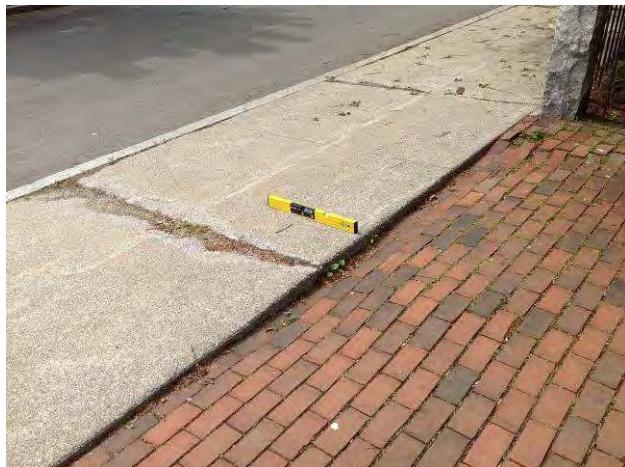
Photo 1

The sidewalks along Robbins Road and School Street are in poor condition. Not only is section of the sidewalk along Robbins Road extremely deteriorated but also the sidewalk along School Street has excessive cross slopes and deteriorated control joints. (Photos 1 and 2)

Repair the sidewalks along Robbins Road and School Street (about 100 feet).

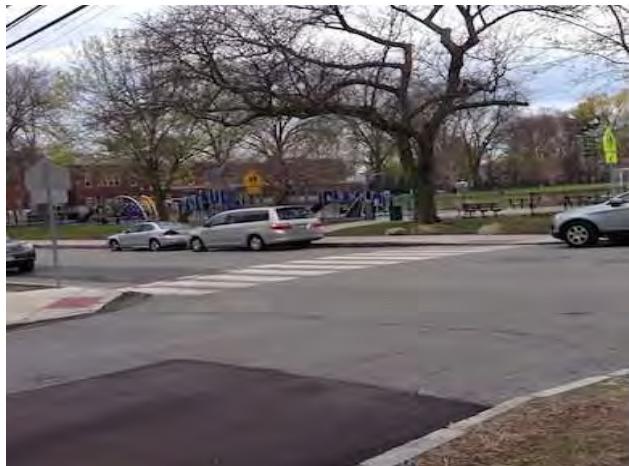
Photo 1

There are 2 highly visible crosswalks with reconstructed sidewalks and curb cuts providing a crossing pathway across Florence Ave. at Waverly St. and Renfrew St. The path of travel at both crosswalks contains noncomplying features, including excessive cross slopes and a noncomplying diagonal curb cut. (Photo 1)

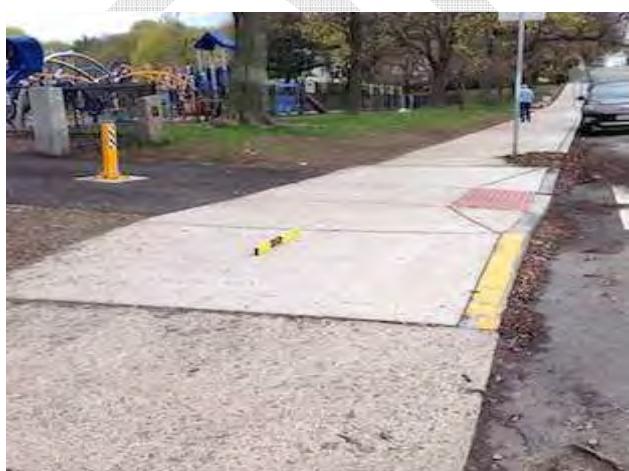
Photo 3

Eastern end of new sidewalk does not blend to compliant slopes where it meets the sidewalk pedestrian zone in front of the school drive-in area (now used for a Four-Square court). (Photo 3)

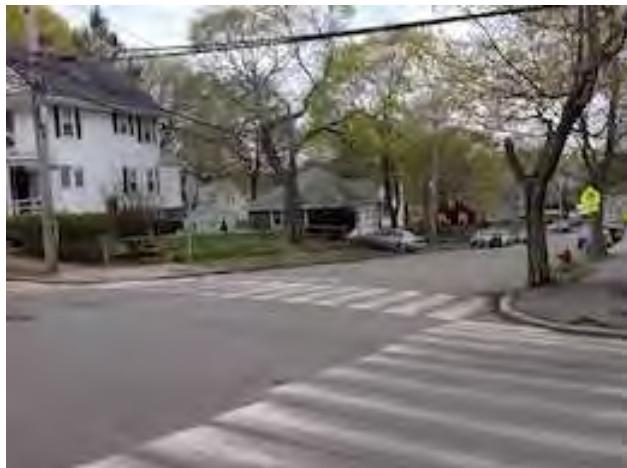
Photo 4

Crosswalks, curb ramps and sidewalks from this location to the new sidewalk panels are in disrepair, inaccessible, and/or missing. (Photo 4)

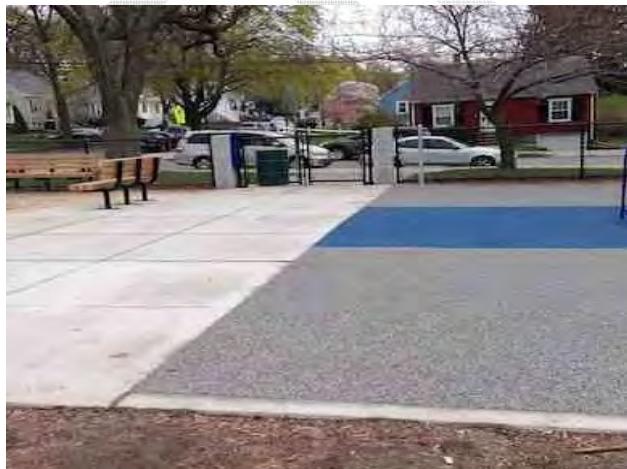
Photo 6

The swinging gate at the Waverly St. entrance now requires a smooth surface on the push side extending the full width of the gate.(Photo 6)

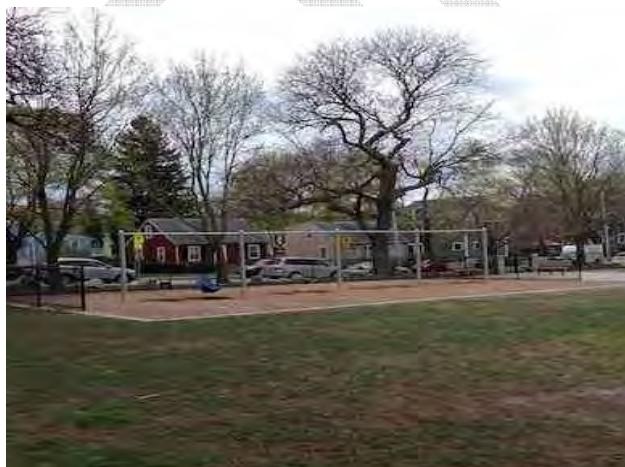
Photo 9

These walkways connect to each other and all play areas via the circuit route; however, neither walkway provides a connection to the other areas of the facility from play areas and entrance. There is no accessible route to:

- boundary of field playing areas;
- benches on eastern side of field;
- portable toilet near east side dugout area;
- team benches;
- equipment storage box at home team dugout; and
- basketball court. (Photo 9)

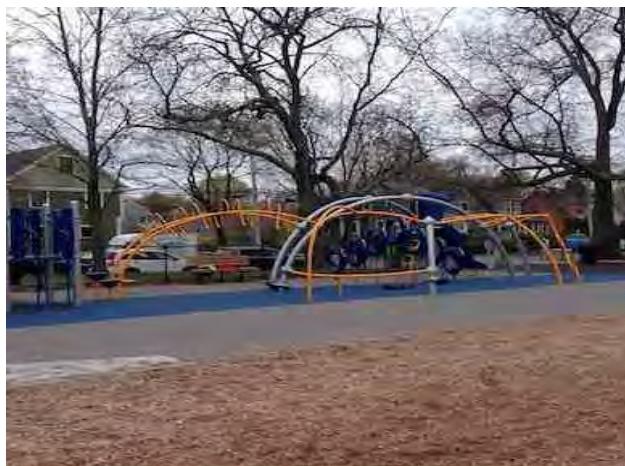
Photo 11

The climbing and swinging structures and the distinctive zip line are play elements for children 5+ that do not provide accessible opportunities. (Photo 11)

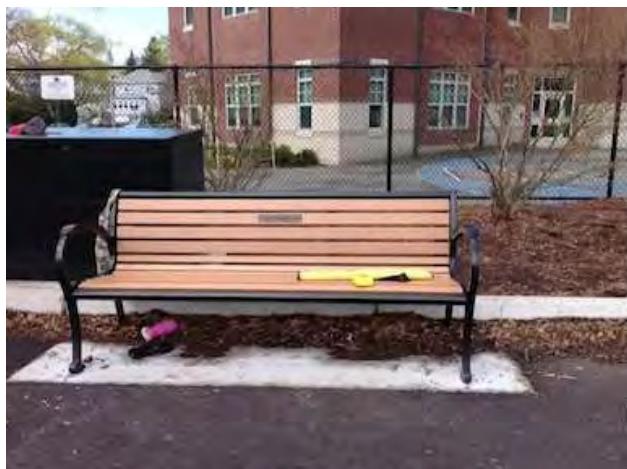
Photo 17

The accessible memorial bench with armrests is located near the Renfrew entrance. This Memorial bench says, *"Dedicated to the memory of Tom Boudreau, Tireless advocate for people with disabilities."* (Photo 17)

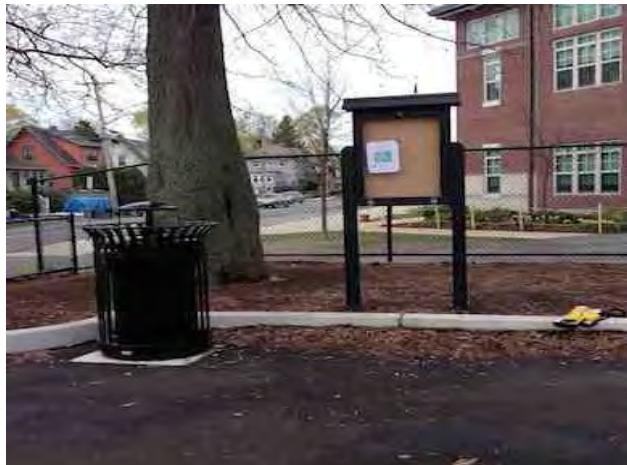
Photo 18

The community bulletin board along the Renfrew entrance walkway is installed on a landscaped and curbed area. Horizontal access to visual characters is impeded because signage area is too high.

The forward approach area in front of bulletin board should be maintained free of debris. (Photo 18)

Lower bulletin board sign mounting section so all signage can be read at between 40 and 60 inches above walkway with a forward approach within 5 feet.

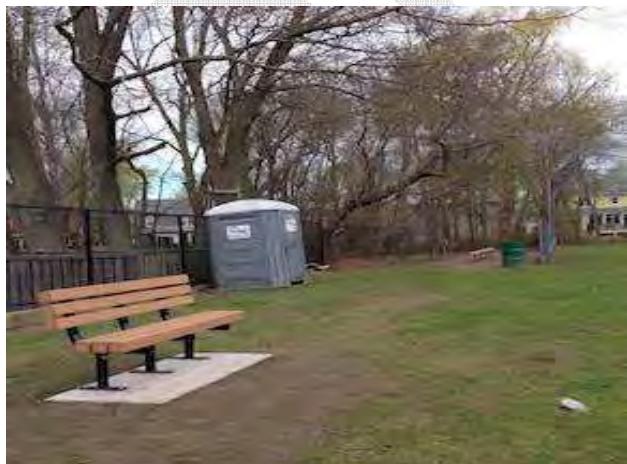
Photo 19

Portable toilet has accessible dimensions but is not located along an accessible route. The threshold height is excessive due to a slight tilt of the amenity. (Photo 19)

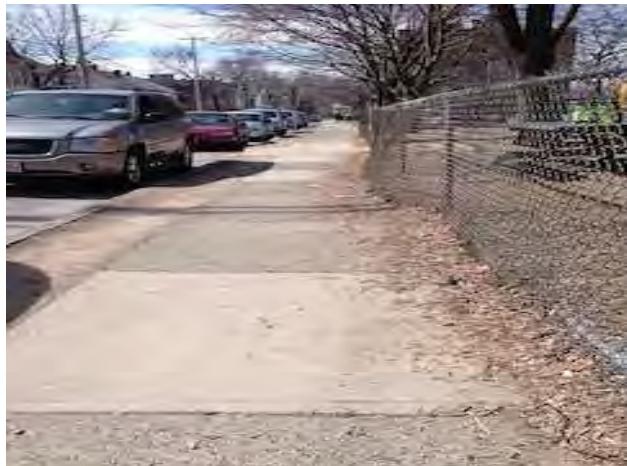
Photo 4

The sidewalks along perimeter of facility on Tufts Street have excessive cross slopes, level changes, gaps and discontinuous surface materials which produce an uneven terrain.
(Photo 4)

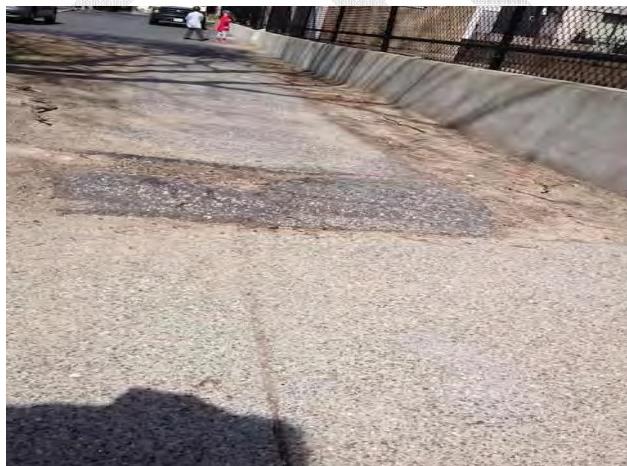
Photo 6

There is no accessible route connecting parking lot to facility accessible entrance. (Photo 6)

Construct accessible route between Mass Ave.
& Broadway public transit stops to accessible
entrance along Tufts St. sidewalk.

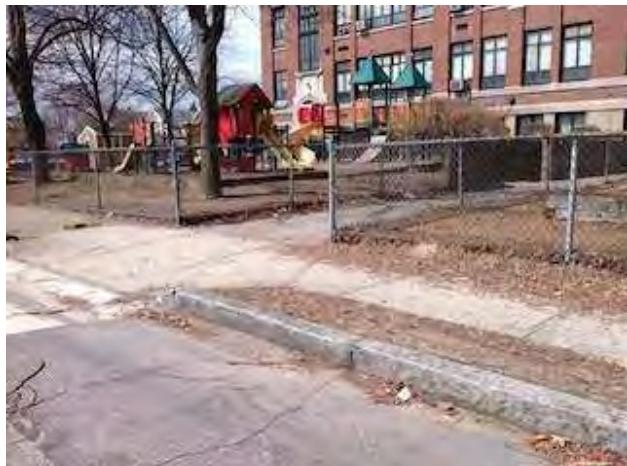
Photo 7

The accessible ramp leading to accessible entrance along Tufts Street needs signage at least as conspicuous as signage at inaccessible entrance. (Photo 7)

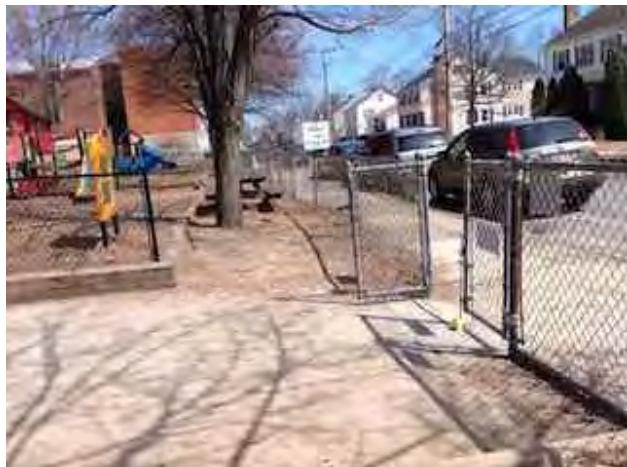
Photo 8

No-step gate to larger playground from Tufts sidewalk opening is too narrow and not along an accessible route. (Photo 8)

Replace double-sided gate to play area near parking with a one-latch gate with 48" opening. Add smooth plate or kickplate hardware on latch side. Mitigate ground surface cross slope issues on both sides of gate.

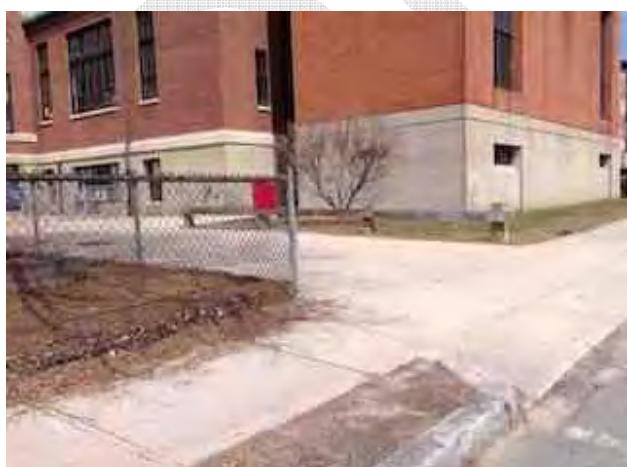
Photo 9

Walkway between Tufts St. and Foster St. passing inaccessible program entrance and picnic table area has vertical level changes over 1/2 inch unbeveled on Tufts St. side and curb ramp with excessive run slope (>13%) on Foster Street side. (Photo 9)

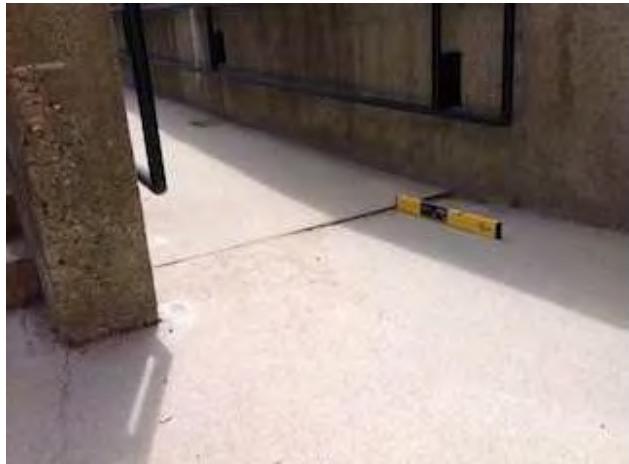
Photo 10

A straight ramp is provided to an entrance door with an automatic door opener on Tufts Street, and between the two playgrounds. Ramp run is accessible; however, the sidewalk to ramp transition is not along an accessible route and includes excessive cross slopes at ramp entry. The transition between bottom of ramp and accessible entrance door has excessive level changes and panel protrusions. (Photo 10)

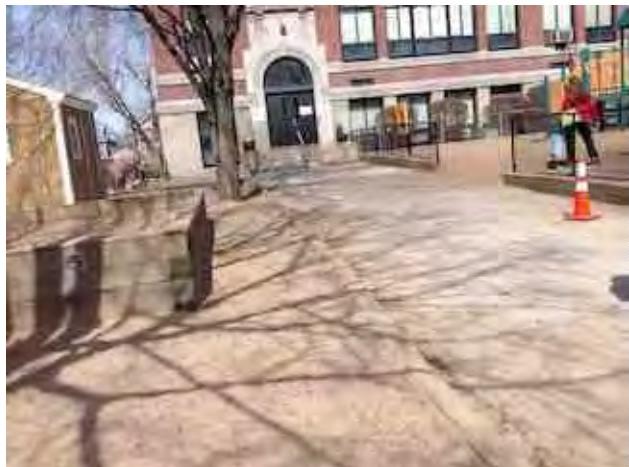
Photo 11

There is no accessible entrance into play areas, and no accessible interior play area route within play area use zone of both playgrounds. (Photo 11)

If play area is altered, replace or replenish ground surface materials at both play areas. Recommend unitary ground surface materials which will comply with both ASTM and Accessible Routes within Play Area requirements. Provide level-graded entrance into both play areas, which connects to accessible route through play areas.

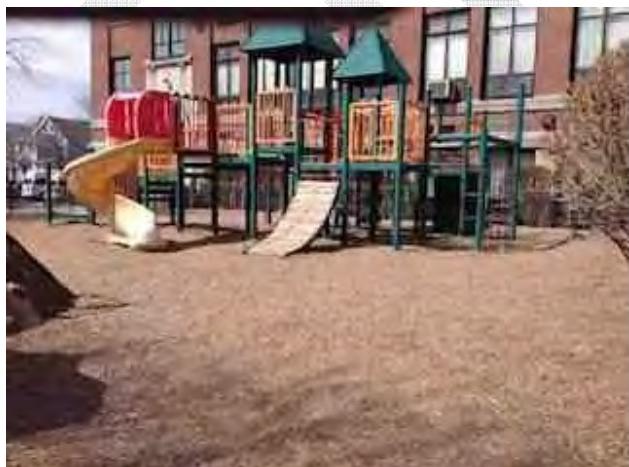
Photo 12

There are more than 20 elevated play components in larger play area and at least 25% are not connected by ramps. None of the ground play components are currently along an accessible route. (Photo 12)

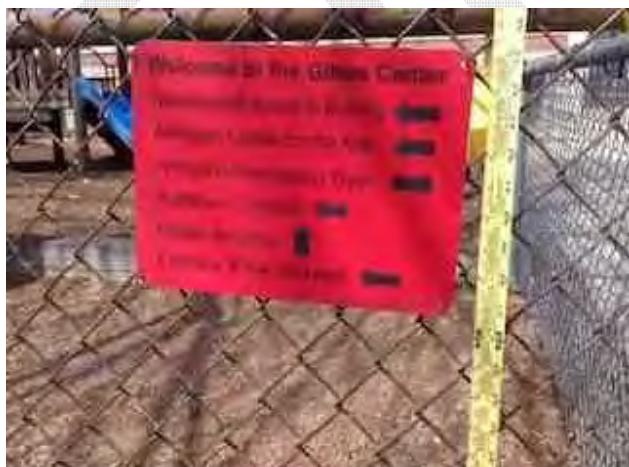
Photo 15

Directional signage mounted along fence around perimeter of facility provides unclear information. (Photo 15)

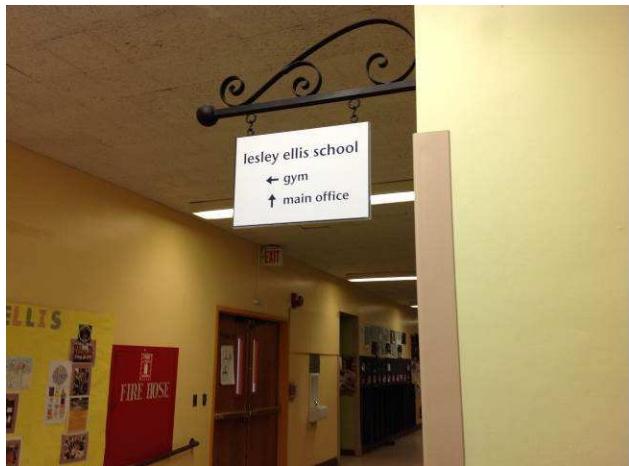
Photo 19

Within Gibbs Center, directional signage to Gibbs Gym is insufficient and poorly located. On level 1, no directory signs are offered at either entrance. Further, the only indication about the location of Gibbs Gym can be found on the control panel inside the elevator. On level 2, the only directional sign to Gibbs Gym is found above the doors to the main office of Lesley Ellis School. (Photo 19)

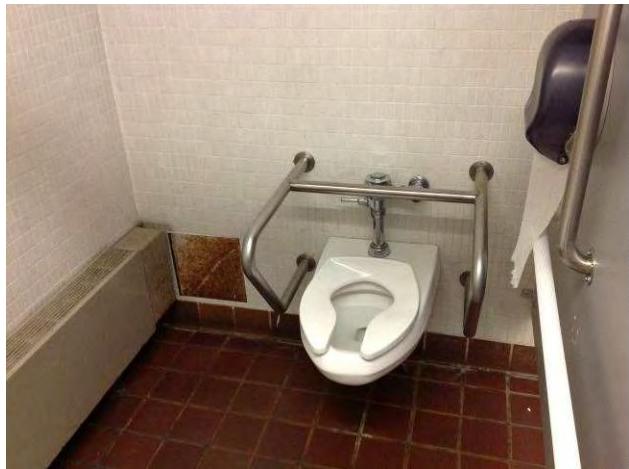
Photo 20

One set of multi-user toilet rooms (one for each gender) is provided near the elevator on level 1. Although these toilet rooms may have been code-compliant at the time of their installation, they do not meet the minimum requirements of either 1990 ADA Standards or the current accessibility laws and regulations. Toilet rooms are inaccessible because faucets are non-compliant, plumbing underneath lavatories are not protected, mirrors are too high (49" above the floor), paper dispenser are too high (52" above the floor), accessible toilet stall have non-compliant grab bars, and no alarms are provided. (Photo 20)

- Replace the faucets of at least one lavatory with ADA-compliant fixtures;
- Protect the plumbing underneath of at least one of the lavatories in each toilet room;
- Lower at least one mirror above a lavatory so that its reflective surface is no higher than 40" above the floor;
- Lower paper dispensers so that their controls are no higher than 48" above the floor;
- Replace grab bars with ADA-compliant accessories inside the accessible toilet stalls;
- Install audible and visible fire alarms.

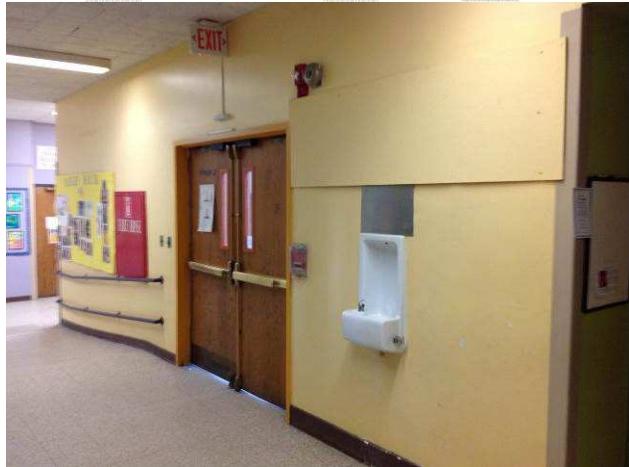
Photo 21

One wall-mounted drinking fountain is provided near Gibbs Gym on level 2. Such fixture is not ADA-compliant. (Photo 21)

Replace the existing fixture on level 2 with an ADA-compliant fixture. In the meantime, provide an adjacent water cooler with cups for equivalent access at the inaccessible drinking fountain.

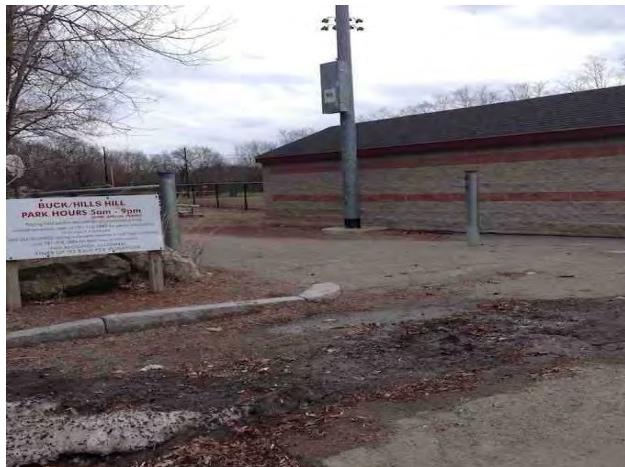
Photo 2

The point to entry that includes facility signage is shared with Buck Field. This entrance is uneven and needs maintenance. (Photo 2)

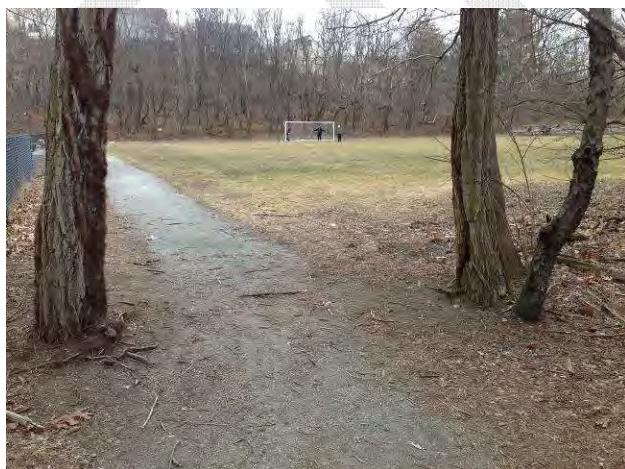
Photo 3

The point of entry from the Bikeway Shared-Use Trail is a well-graded stone dust pathway. (Photo 3)

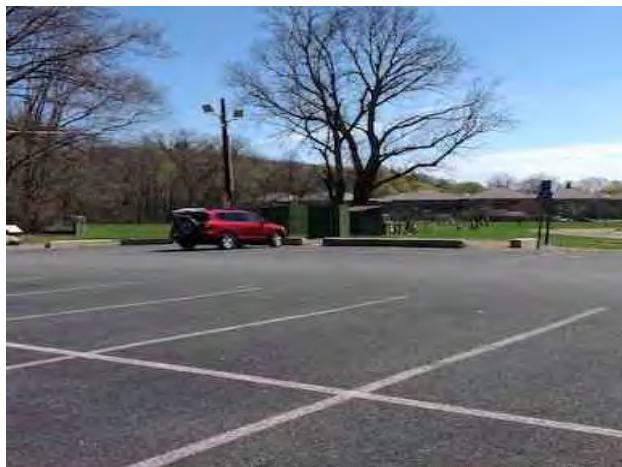
Photo 5

The Drake Road Parking lot is well maintained, and has approximately 62 spaces, with at least 4 accessible spaces. (Photo 5)

There is no accessible route connection between the accessible parking spaces at this lot and the field programs and amenities it supports.

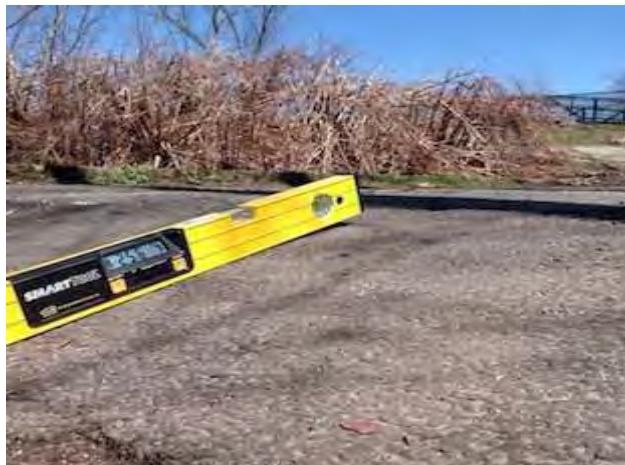
Photo 8

Secondary trails branching off the trail to Wildlife Garden and in the direction of Hurd Field are excessively steep and are not usable until they can be re-graded to minimal slopes with additional natural wall (or handrail) supports. (Photo 8)

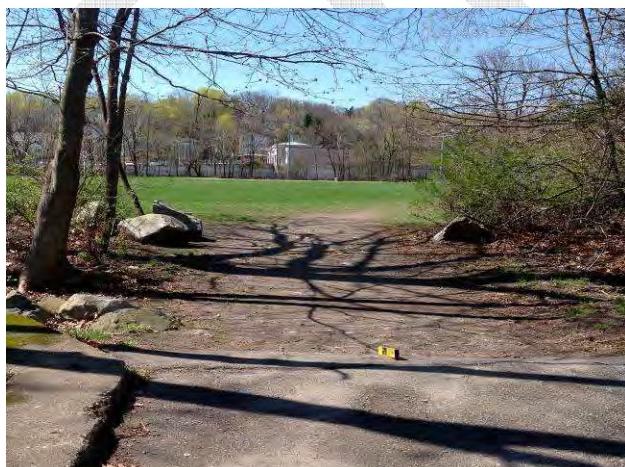
Photo 9

The informal trail between the back of Hurd Field and the Reservoir Trail at the spillway bridge is particularly hazardous and does not provide an accessible connection between the two sections of this multi-use facility. (Photo 9)

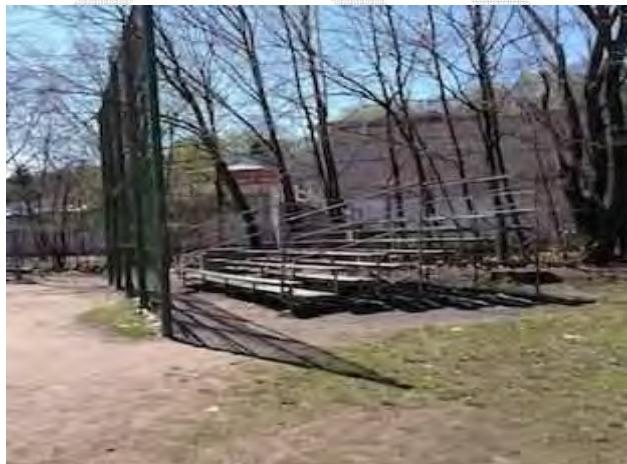
Photo 12

There are no accessible route connections to the spectator bleachers at the larger Hurd Field ballfield at this time. These are not accessible bleachers and there is no clear, firm and level ground spaces provided for wheelchair spectator locations. (Photo 12)

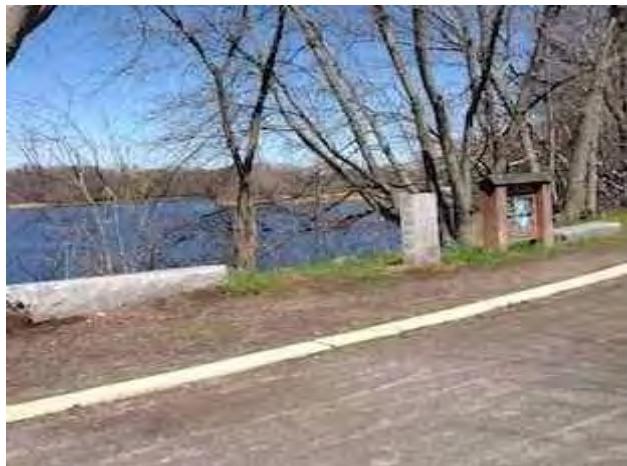
Photo 13

The sign explaining the EPA Porous Pavement project at the Drake parking lot; and the Map installation at the Lowell St. Trail entry point do not provide accessible clear ground approach and viewing conditions due to mounting heights (EPA sign) and distance from trail edging (Map). (Photo 13)

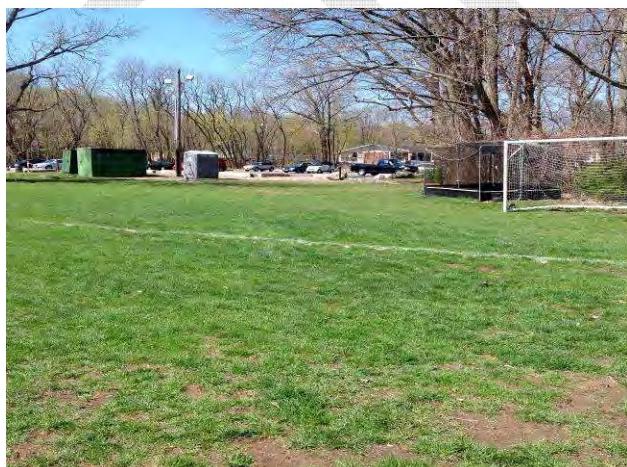
Photo 15

A portable toilet installed at the edge of Hurd Field is not adjoining an accessible path and does not provide an accessible level, firm ground surface for entry. (Photo 15)

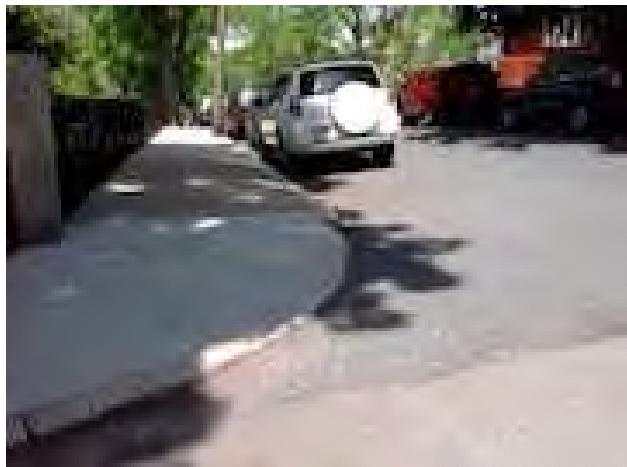
Photo 2

Curb ramps at intersection of Paul Revere Road and Davis Ave. are inadequately constructed, with excessive run slopes, no flared sides, and a non-gradual transition to street. (Photo 2)

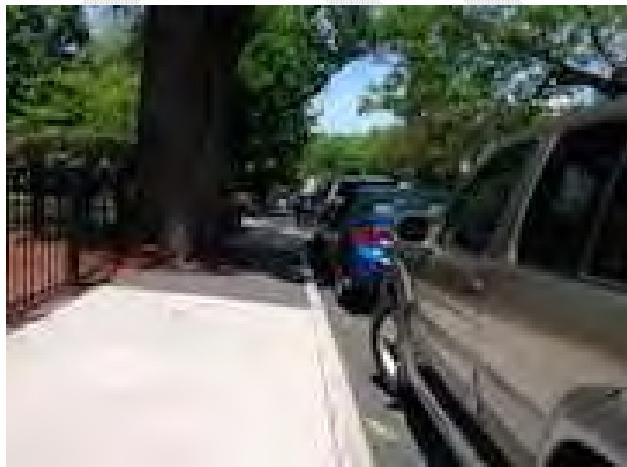
Photo 3

Sidewalk panels from Paul Revere Road down Davis Ave. to the Park have been sporadically replaced. New and older sidewalk panels have noncomplying cross slopes. (Photo 3)

When future sidewalk alterations are made to Davis Road, reevaluate and replace panels to ensure consistent cross slopes to the maximum extent possible.
